06.02.2023 Kahramanmaraş Earthquake

FIELD INSPECTION

TÜRKİYE – JAPAN

08.03.2023 - 11.03.2023

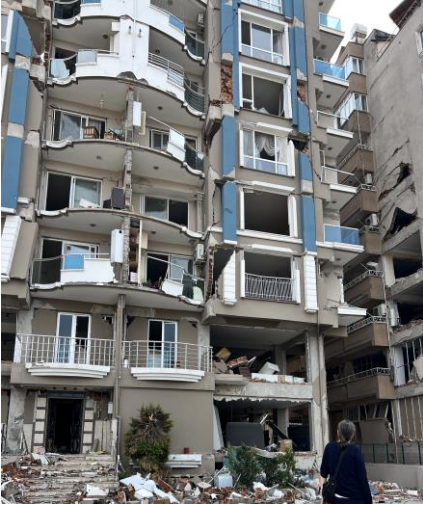
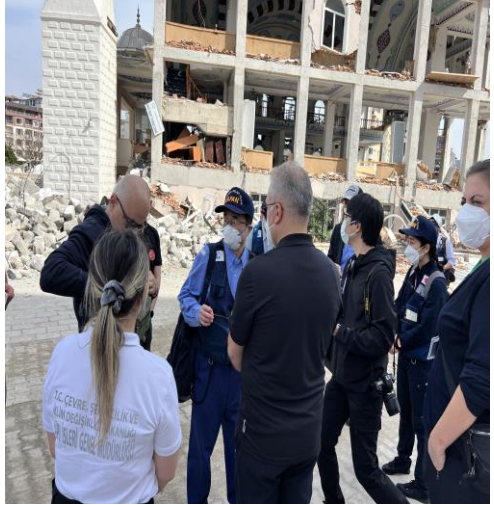
Damaged buildings located on 75 Yıl Boulevard in Antakya district of Hatay province were examined, and Doğa Apt. and Hacı Suat Yılmaz Mosque, how the damage assessment procedures are carried out in our country are explained in detail, both practically and verbally. Information on how these transactions are done in Japan was obtained. In addition, the questions directed by the Japanese delegation to us were answered by the experts on the subject. (Photo 3-4)

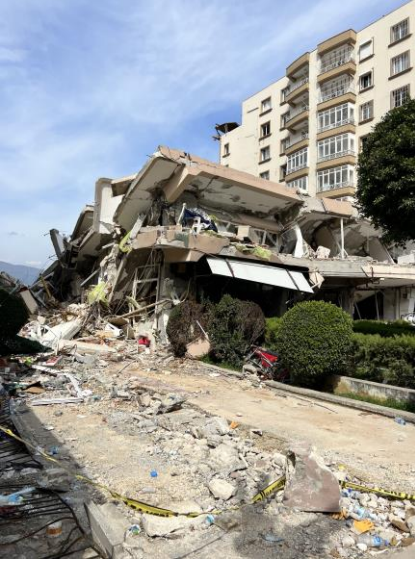
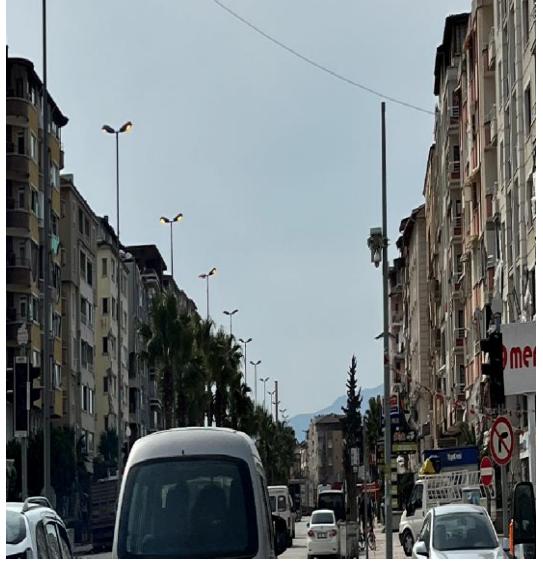
Investigations of the destroyed, urgently to be demolished, heavy, medium and lightly damaged buildings along 75. Yıl Boulevard continued. (Photo 5-6)

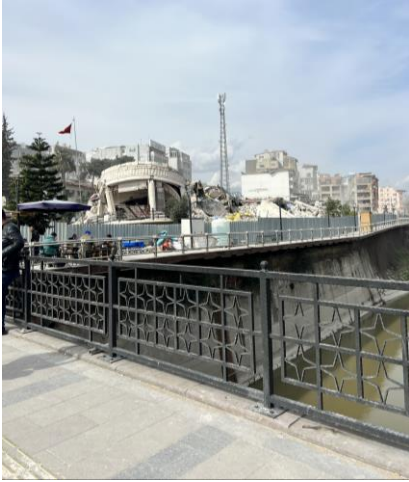
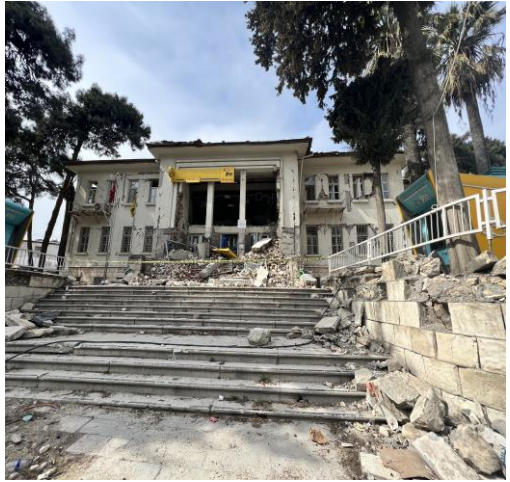
It has been seen that the Antakya Parliament building, which is a cultural heritage, has been destroyed and its wreckage has been examined. By giving information about the legislative practices in our country, information about the practices in Japan was obtained and a comparison between countries was made. (Photo 7-8)

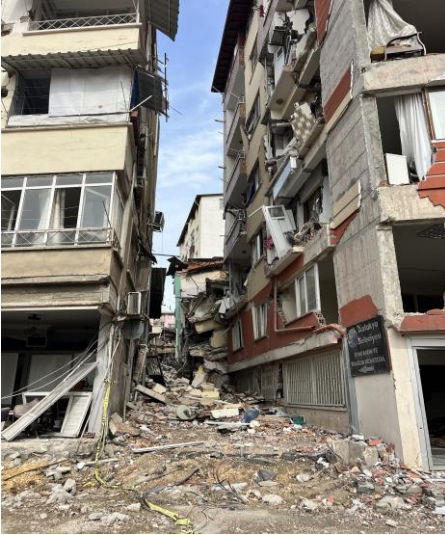
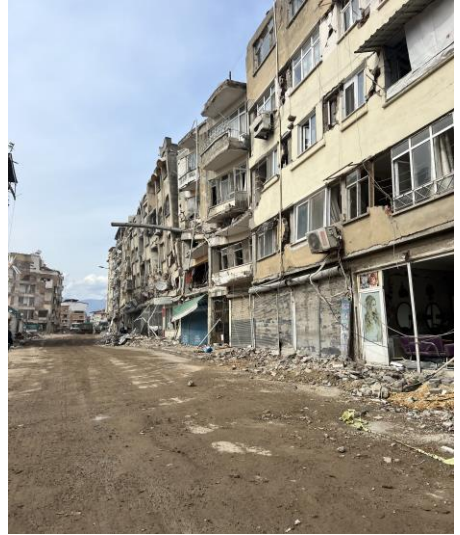
In Cebrail Neighborhood Cengiz Street, heavy, medium and lightly damaged buildings, debris investigations of collapsed buildings were continued and debris removal works were examined and information was obtained about how these operations were carried out in Japan. It was observed that the destroyed buildings were mostly old buildings that did not receive engineering service or were built according to the old earthquake regulations. (Photo 9-10)

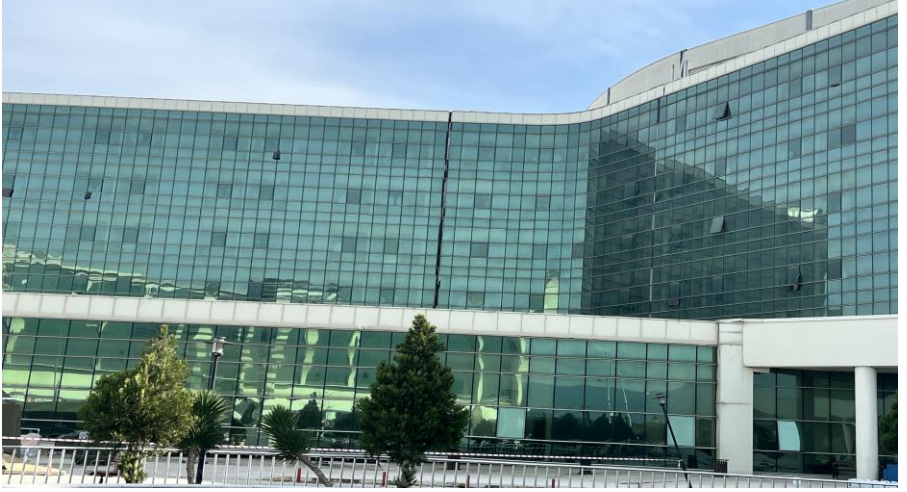
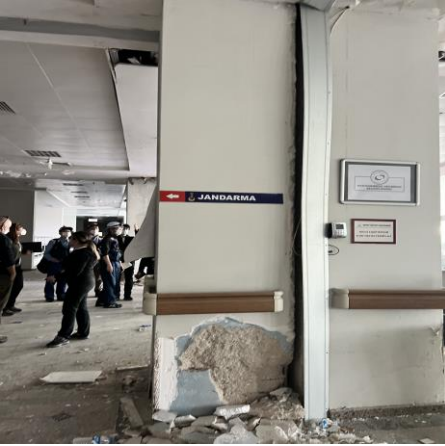
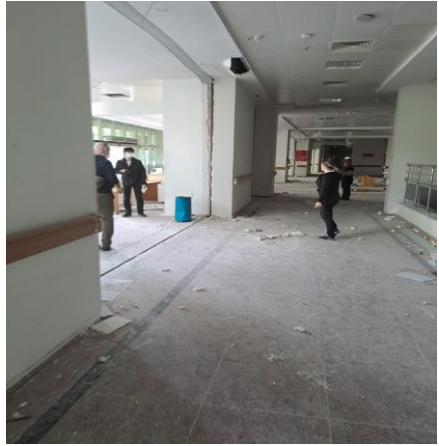
In the examination carried out in Hatay Training and Research Hospital, which was determined to be heavily damaged; It has been observed that there are settlements on the floor of the building and it is separated from the dilatation joints. However, the technical committee from Japan stated that such damaged buildings can be retrofitted if they remain in an advantageous position according to the cost analysis in their own country. It was stated that the cause of the damage in the hospital building was mostly caused by the ground, and the building could be strengthened. Information was requested by the Turkish delegation about the applications of this type of reinforcement (ground and building) in Japan. It has been stated by Japanese experts that buildings with this type of settlement are lifted from the ground with jack-like tools and that, in addition to soil improvement works, they can be strengthened and used from the foundation of the building with the application of piles. It was stated by the Turkish delegation that if this building is strengthened by the methods mentioned on-site by Japanese experts, they will bring an example to our country in terms of ground and foundation reinforcement. (Photo 11 - 12 -13)

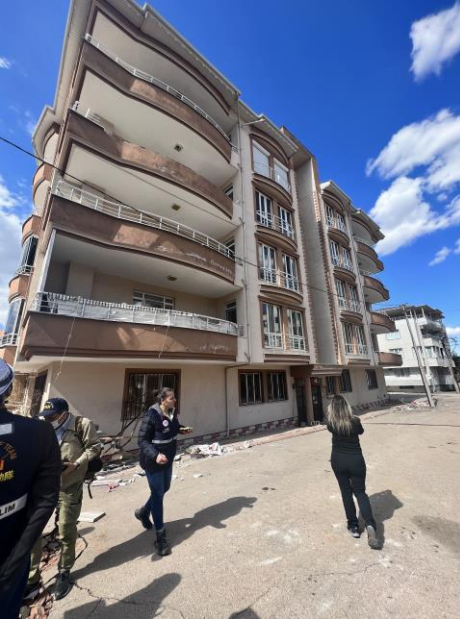
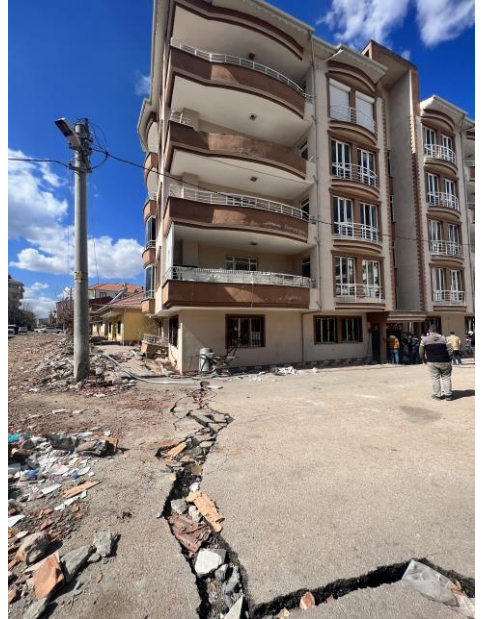
Investigations were made in the Çınar Apartment, located on the Azerbaijan street of Gölbaşı district. It was clearly observed that the building, which was determined as severely damaged by the damage assessment teams, had settled due to ground liquefaction. In addition, during the examinations made inside the building, it was determined that there were no cracks in the carrier system. (Photo 17-18)

When the Japanese delegation was asked about the building, it was stated that this building could be saved, just like the previous hospital building, and it was repeated that the building could be continued to be used by lifting the building with oiled jacks, improving the ground, and placing the building back in its place.

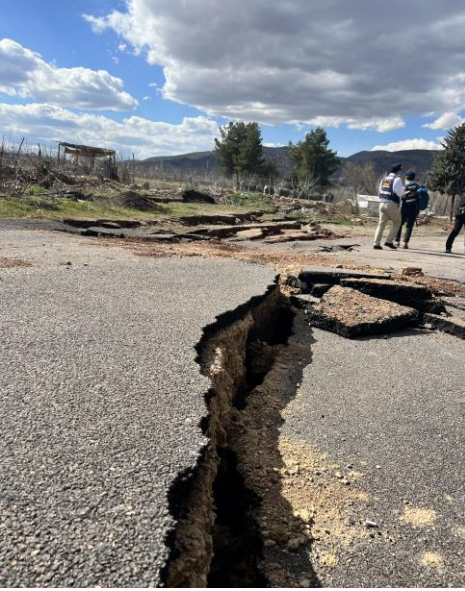
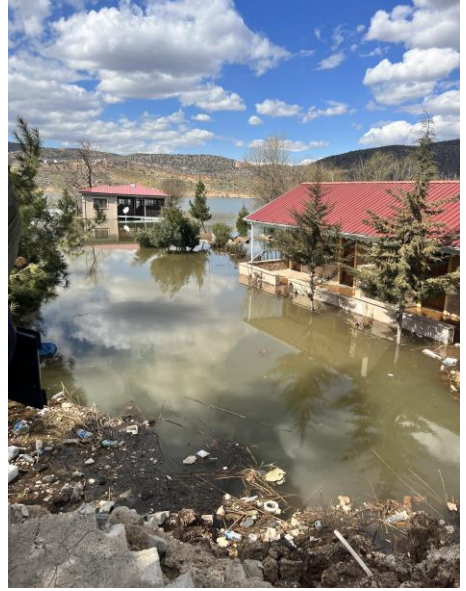
Slumping and collapses are observed in the buildings used as social facilities located on the lakeside of Gölbaşı, and ground slippage and soil liquefaction were observed in the region. (Photo 19-20)

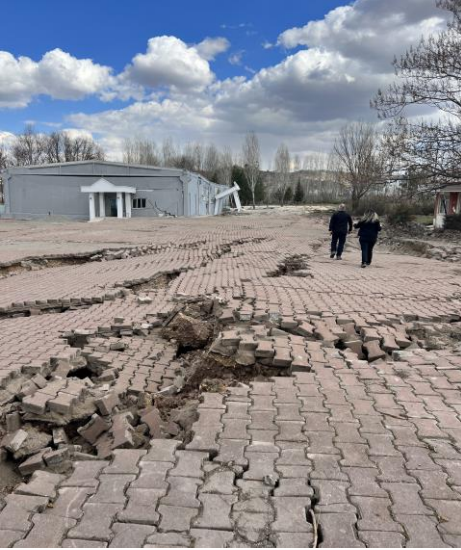
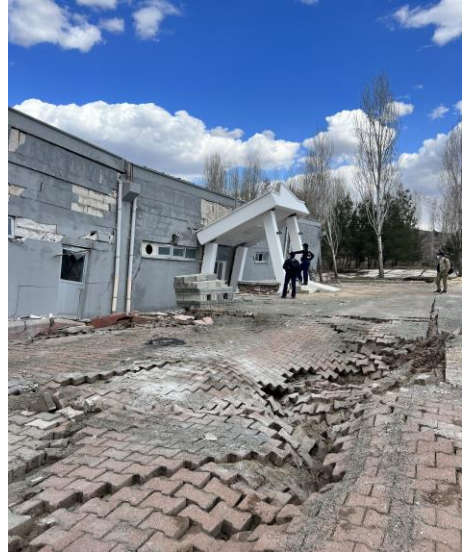
Investigations were made in a prefabricated building located on the lakeside of Gölbaşı, and it was observed that the structure collapsed approximately between 60 and 100 cm in places, where there were decompositions in the junction areas of the prefabricated elements of the building due to the liquefied soil. (Photo 21-22)

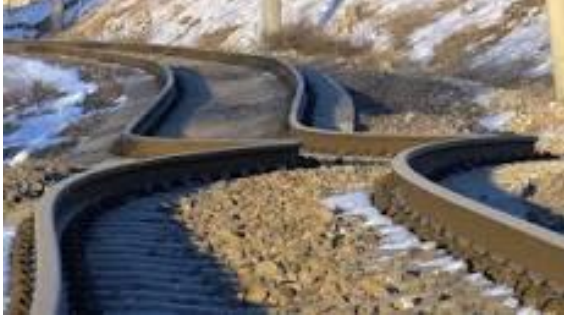
Photo 23

The effect of the earthquake in the region was observed once again on the train line from Gölbaşı to Adana. (Photo 23)

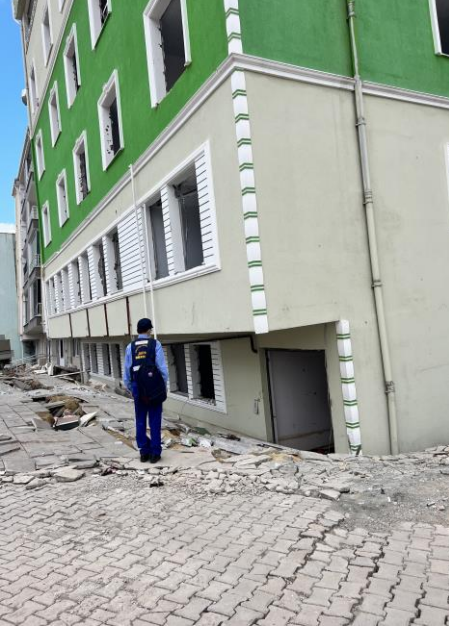
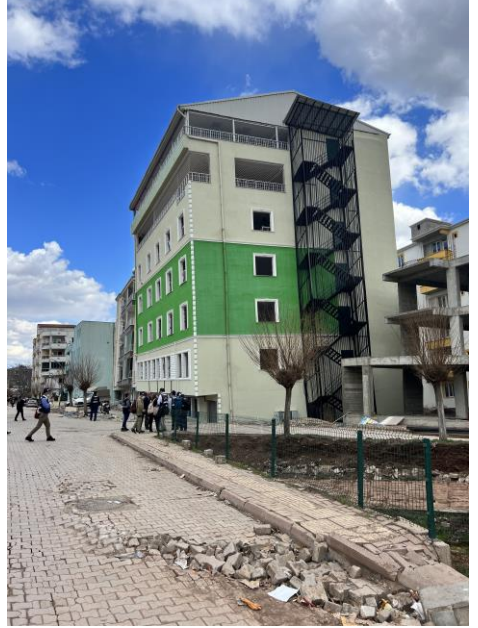
In the examinations made in the Mufti building located on Gazi Street in Gölbaşı district, it was determined that the building settled due to liquefaction of the ground, like the general of Gölbaşı district. However, it was stated that during the construction phase of this building, soil improvement was made and pile foundation was applied on the ground, and information was obtained from the company that made the piles about the work they did at the building site. It was stated that 38 piles were used in the building in total, they had a depth of 12 m and were made with 4 reinforcements, and it was seen that the application was insufficient. (Photos 24-25)

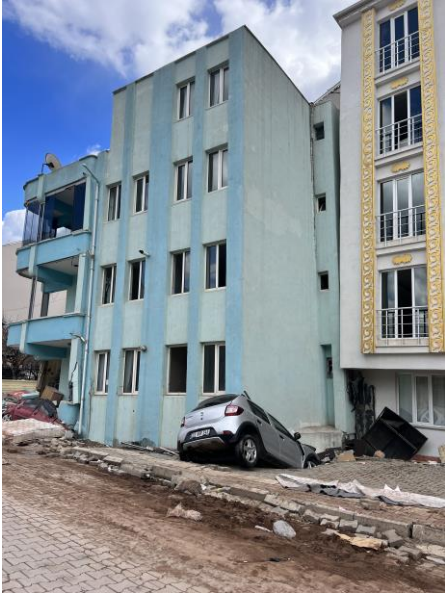
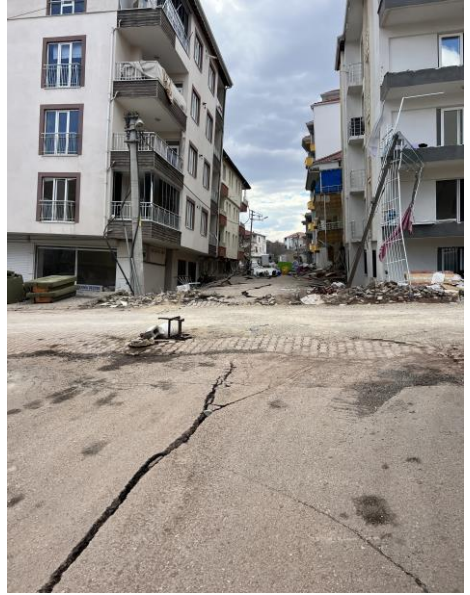
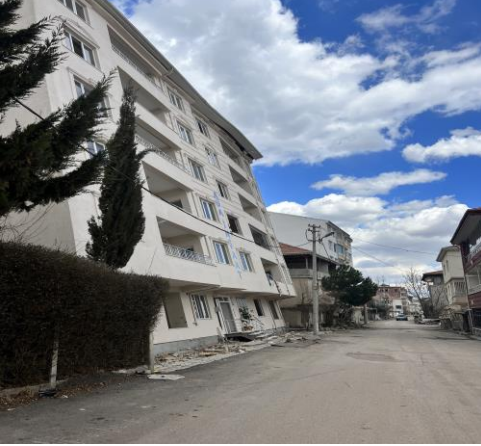
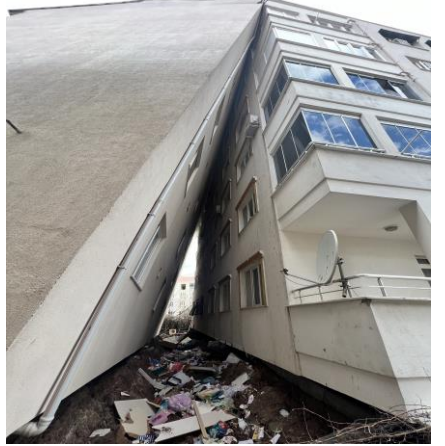
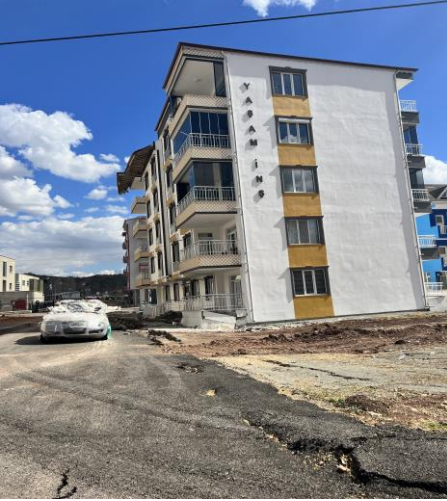
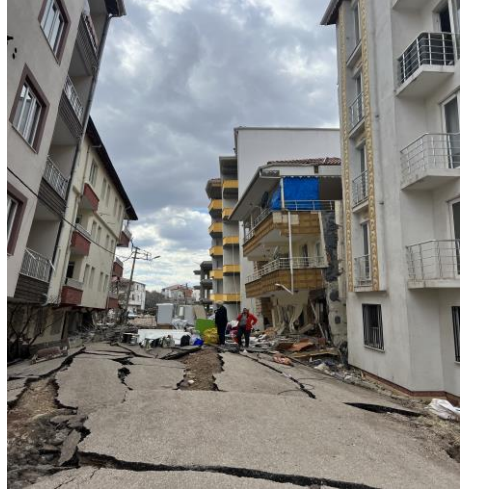
The Japanese delegation was informed about the ground surveys and ground improvements in our country, and they were asked how the applications were made. It was stated that the improvements with piles continued until the hard ground, and that at least 28 reinforcements were placed in it. (Photo 26-27-28-29-30-31)

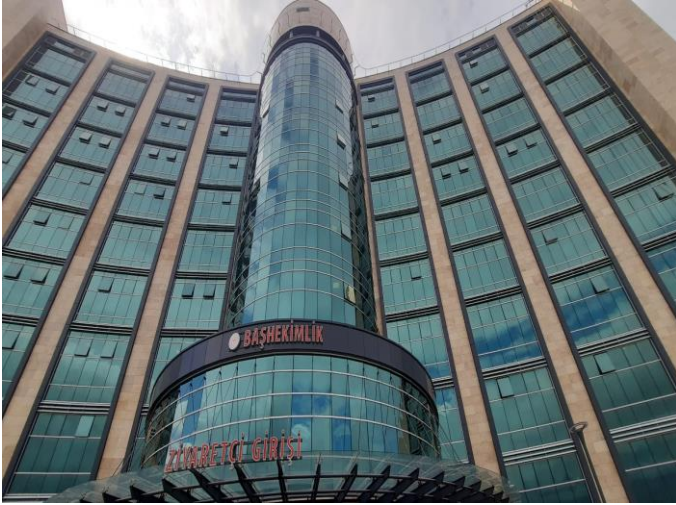
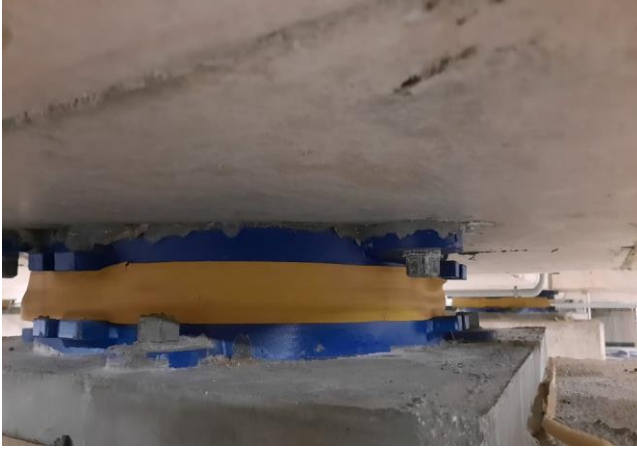
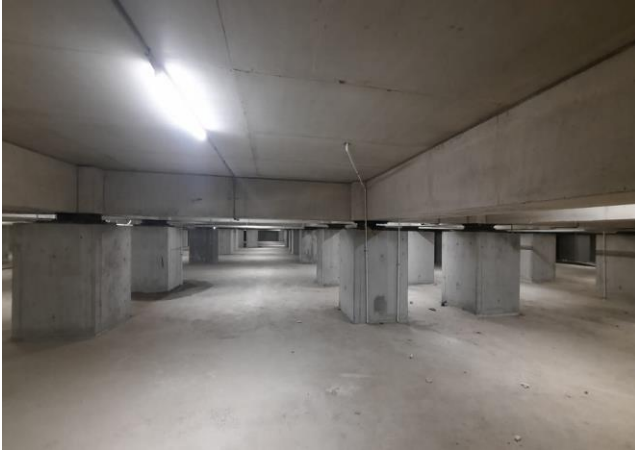
After the meeting, Hatay-Dörtyol State Hospital, a building with an insulator application, was visited. It was observed that the building, which has 341 seismic isolators, did not suffer any damage in the 3 major earthquakes and aftershocks. The hospital continued its activities uninterrupted during and after the earthquake. (Photo 34-35-36)
