06.02.2023 Kahramanmaraş Earthquake

FIELD INSPECTION

TÜRKİYE – JAPAN

08.03.2023 - 11.03.2023

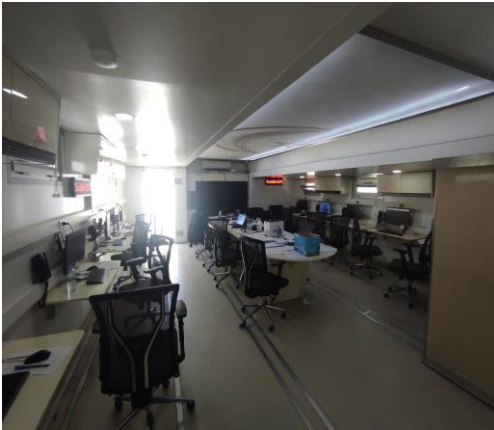
Photo 1

The "Coordination Center", where damage assessment studies are carried out in the city center of Hatay, was visited and the methods and types of damage assessment processes were explained. In addition, the damage assessment software and the coordination center were introduced, and it was learned that the damage assessment processes, which do not have a software in Japan, are archived on paper documents. (Photo 1-2)

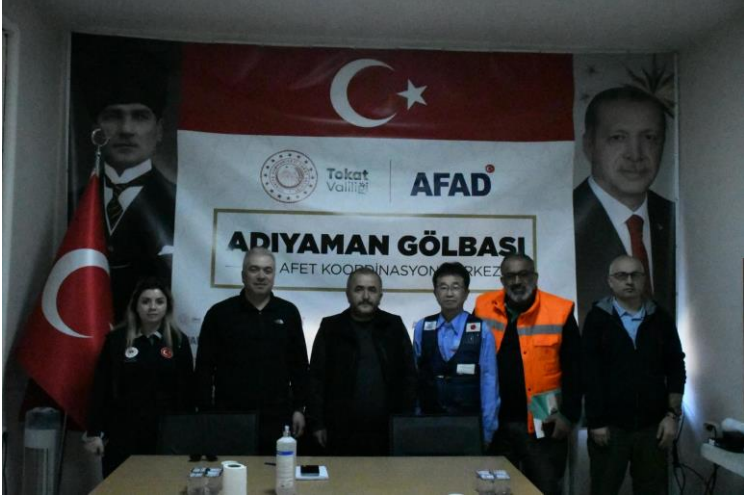
Photo 15

A visit was made to the "Coordination Center", where damage assessment studies are carried out in Gölbaşı district of Adıyaman, and information about the works was obtained by interviewing Numan HATİPOĞLU, the coordination Governor. The support that can be given was evaluated by the Japanese delegation by learning the needs of the district. (Photo 15)

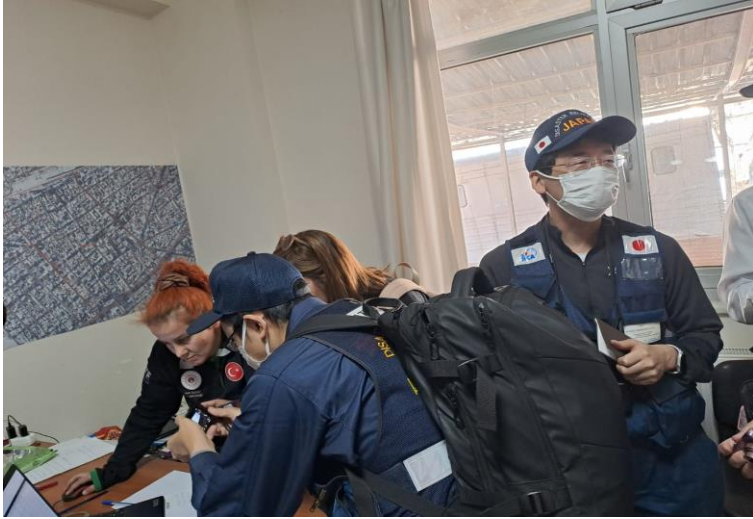
Photo 16

Following the meeting, information was given about the suspension procedures after damage assessment and the maps on which damage assessment was processed. (Photo 16)

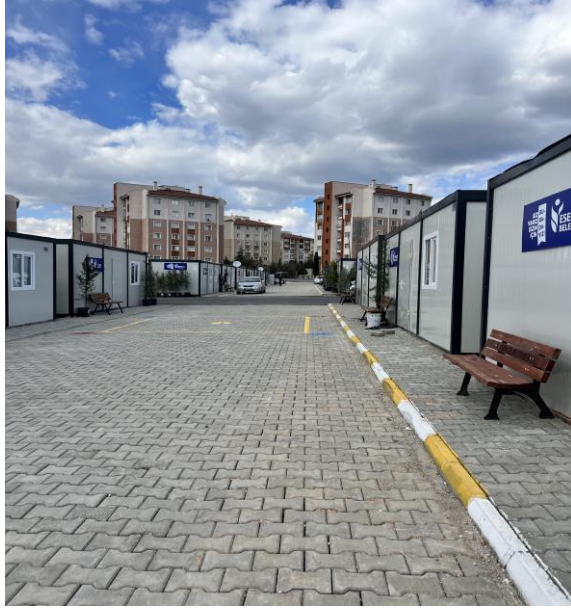
Photo 32

The container city established in Mimar Sinan District was visited regarding how the temporary shelters were built after the earthquake, 688 containers are planned in the region, there are currently 300 containers, container installation works are continuing, 1 family is placed in each container, connections to the sewerage for waste water are made, measures taken for the summer, security, social areas, etc. information on the subject. (Photo 32)

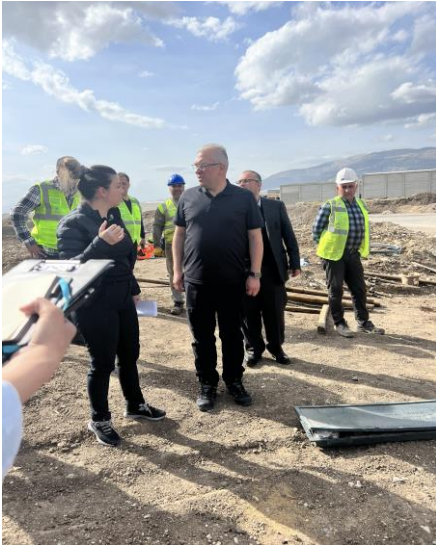
Photo 39

In addition, the site selection studies of the newly established industrial site were examined, the Spatial Planning General Manager Assist. Mr. Ahmet BEKTAŞ has been informed. An area where drilling works were carried out related to these studies was visited. Legislations in our country regarding drilling works were conveyed. Information about the storage conditions and experiments of drilling samples was given and the application in Japan was asked. I was told that there is a similar application. (Photo 39-40)
